CASE STUDY

Multi-Family Building | San Antonio, TX

Project Summary

Repair of failing foundations on two buildings that were sinking due to moisture and soil conditions, and the weight of the structures on these soils.

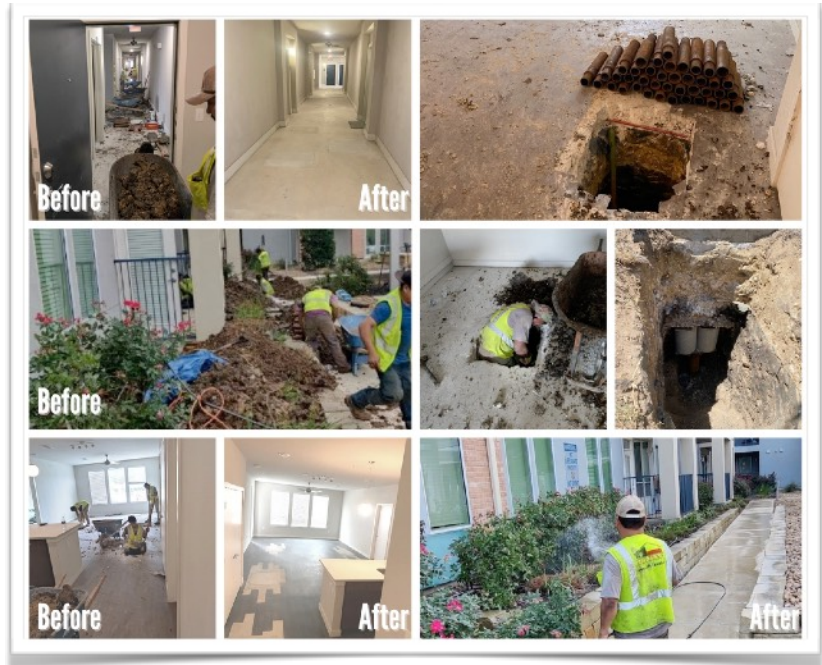
We were contacted evaluate the foundations of multiple buildings at the multi-family property which were failing. On the exterior, there were multiple signs of stresses on the framing, windows, walls, etc....Inside the building, cosmetic cracks were prevalent in many areas as well as on the floors where the floor had dropped.

Solution: Once a plan of repair was presented to the management group, Lift-Texas was given the go ahead. We communicated with the onsite property management and mobilized to install nearly 500 steel piers between two buildings. The piers were pressed to the point of refusal, and then used to lift the structures back to as close to level as possible without causing any further structural or cosmetic damages. We completed this job well ahead of the timeline and the clients were extremely pleased with the results.
