CASE STUDY

Warehouse Void Fill | Carrollton, TX

Project Summary

Interior floating slab had been compromised due to fire riser break.

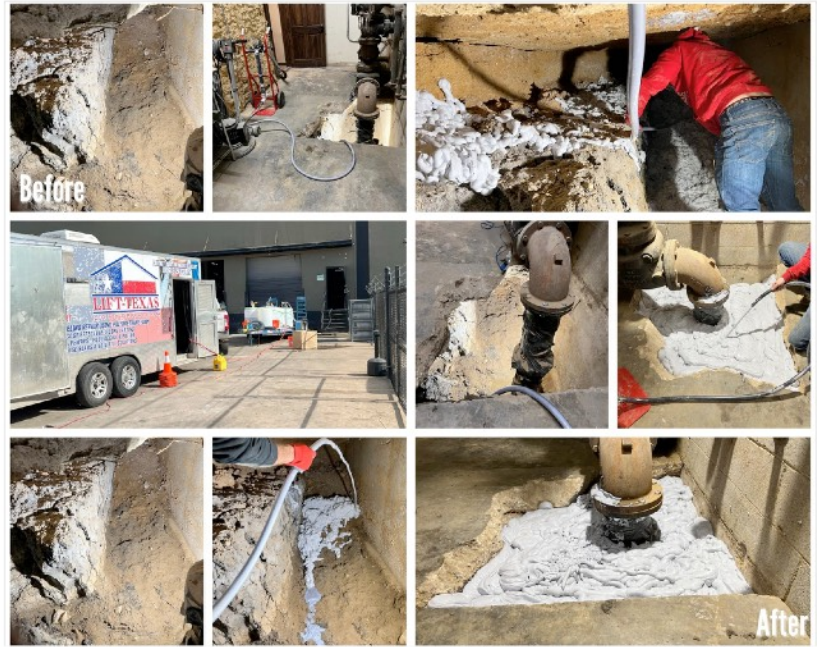
We were contacted to evaluate the collapse of a fire riser that had created a large void. The interior slab had ruptured.

Fire riser gave way and ruptured creating large voids underneath the slab. A portion of the slab was cut out and repoured while another portion was deemed salvageable by the engineering firm by use of poly urethane injections.

Solution: Lift-Texas Construction strategically drilled 84 (5/8") holes into the slab to insure proper coverage of the polyurethane injections. After injecting 400 pounds of polyurethane foam underneath the entire slab to fill all voids, the job was a success and the client was happy.
