CASE STUDY

Residential Pool Void Fill | Arlington, TX

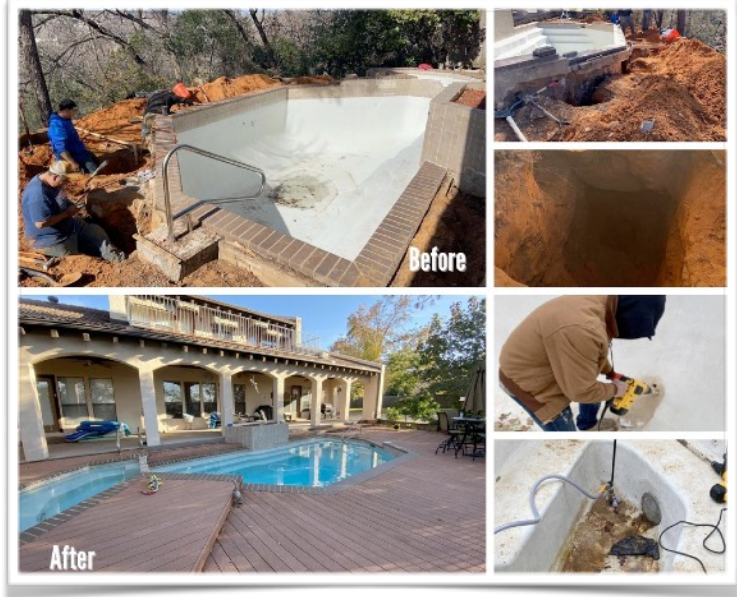
We were contacted to evaluate the homeowners pool that was located on a hillside. We noticed foundation was unloved, the hillside had eroded, and the structure was unstable.

This pool was located on the side of a hill and as with most all structures built on a hillside comes erosion and shifting of the soils around which in turn causing the "foundation" to shift.

Solution: Lift-Texas Construction first installed steel piers under the entire perimeter of the pool to insure it was lifted/stabilized. Secondly, we strategically drilled 5 (1") holes thru the pool/spa interior shell to insure we covered the entire pool and the void left behind from the pier lift. The product we used in this case is FillFoam, it is a two-part resin/hardener that does not lift and can flow hundreds of feet from just drilling one hole. Once the void was filled, we cleaned up and the client was super happy we fixed his issue!.
