CASE STUDY

Commercial Building | Dallas, TX

Repair of failing foundations on a 400,000 Sq Ft tilt-wall warehouse that was dropping due to water intrusion, poor soil conditions, and the weight of the structures on these soils.

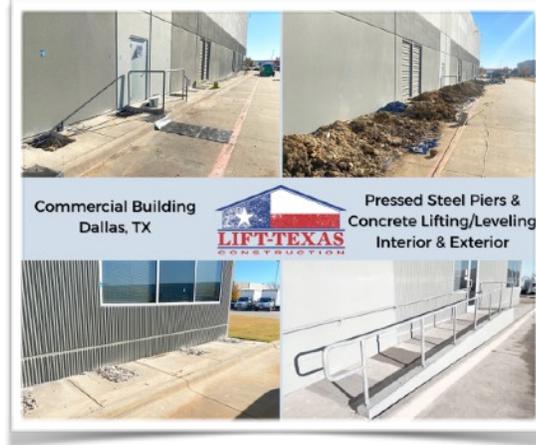
Problem: Lift-Texas Construction, LLC, surveyed the location (inside and out), taking elevation measurements to determine locations where remediation was needed. On the exterior, there were multiple signs of stresses and separation in the tilt-walls. The drop of the tilt-walls on the exterior of the building had also dropped the sidewalks around the perimeter building causing additional water intrusion. This water intrusion, along with the drop of the tilt-walls caused a void to form under the interior floating slab.

Solution: Once the plan of repair was presented to the management group, Lift-Texas was given the go ahead to fix the issues with the foundation. We mobilized to install 82 steel piers on the tilt-walls around the perimeter. The piers were pressed to the point of refusal, then the original builders' piers were disabled. Disabling the original builders' piers allowed us to lift and stabilize the walls as close to level as possible without causing any further structural or cosmetic damages. Once the lift was complete, and we had a passing plumbing test, we moved to the interior using the polyurethane injection to void fill and stabilize the floating slab. We completed this job well ahead of the timeline and the clients were extremely pleased with the results.
